SALISBURY TOWNSHIP NATURAL RESOURCE INVENTORY

**FINAL REPORT
JUNE 2011**

**SALISBURY TOWNSHIP
NATURAL RESOURCE INVENTORY**

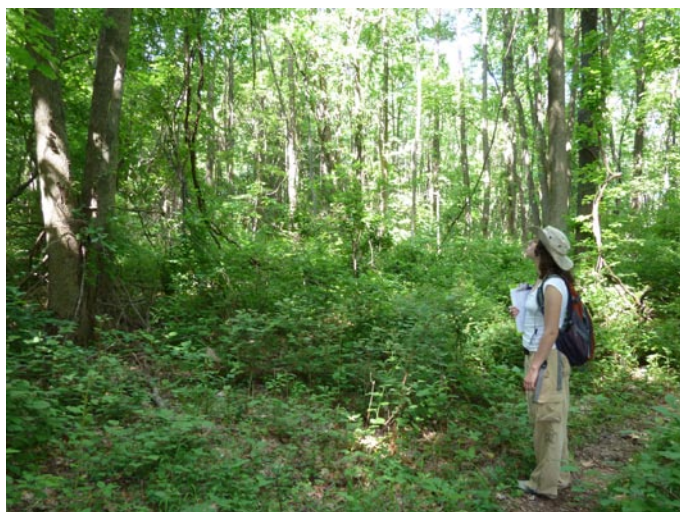
Younger forest with invasive plant species dominating the understory

Recommendation: On a pilot project basis, take on the removal of invasive plants and replacement with natives, working to establish healthy native plant communities. Substantial resources exist about the best methods for dealing with different types of invasive plant communities; Pennsylvania State Cooperative Extension Service and the Pennsylvania Department of Conservation and Natural Resources both are actively involved in researching the control of invasive species in Pennsylvania.

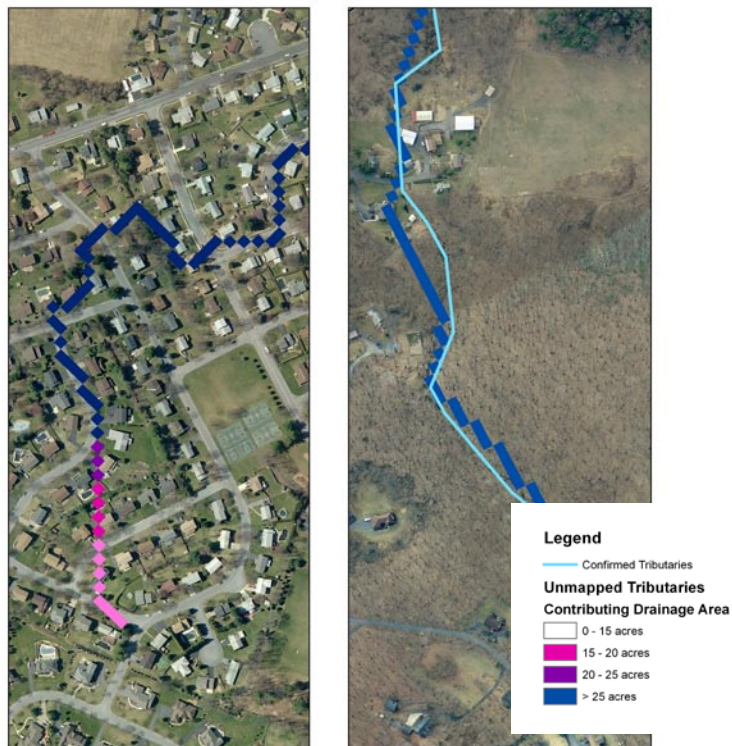
The picture on the left displays a predicted stream in an urban setting that was not confirmed in the field; the picture on the right displays a headwater stream along the mountain that was verified by staff.

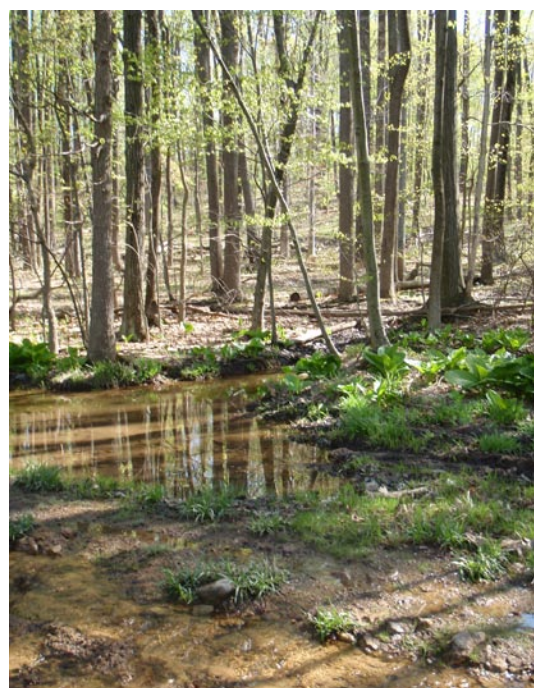
Vernal pool disturbed by ATV traffic.

Recommendation: Enact protections that protect these features. Include clear definitions of each feature in both the Zoning Ordinance and SALDO.

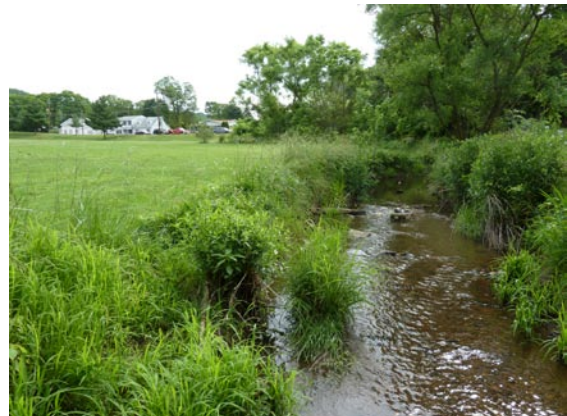
Riparian Zone Condition Ideally, all streams should be protected by a forested meadow or riparian buffer of full-height (i.e., not mowed) trees or meadow grasses. This buffer protects the stream from overland runoff, removes pollutants such as nutrients and silt, and stabilizes the banks with deep, thick root systems. There was quite a bit of variability in the riparian zone condition along the Trout Creek, from excellent (a buffer over twice as wide as the stream is) to poor (stream bank mowed to the edge or paved). Where ratings were “fair” and “poor,” opportunities exist for improving the buffer condition.

According to recent regulations put in place by the PADEP, all streams are best protected by a stream buffer of at least one hundred and fifty feet (150').

Recommendation: Where riparian buffers are less than “excellent,” contact landowners with information about the benefits of riparian buffers and resources available to encourage their installation.

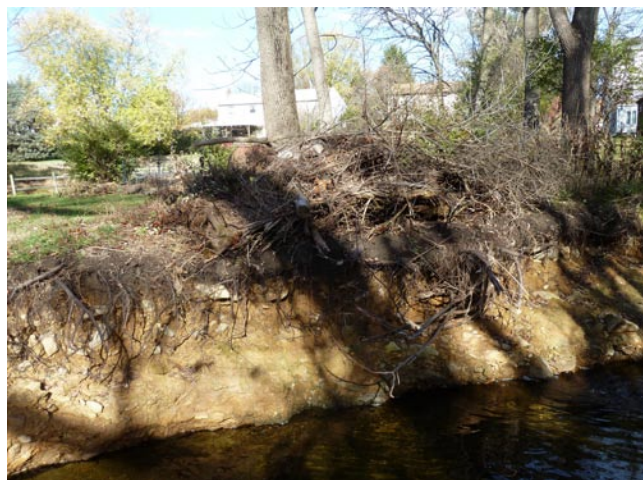
Typical extent of bank erosion throughout the reaches of the Trout Creek

Recommendation: Develop plans for streambank stabilization projects and the planting of native riparian buffers on all the stream segments that rate as “fair” or “poor,” to control stream bottom sedimentation.

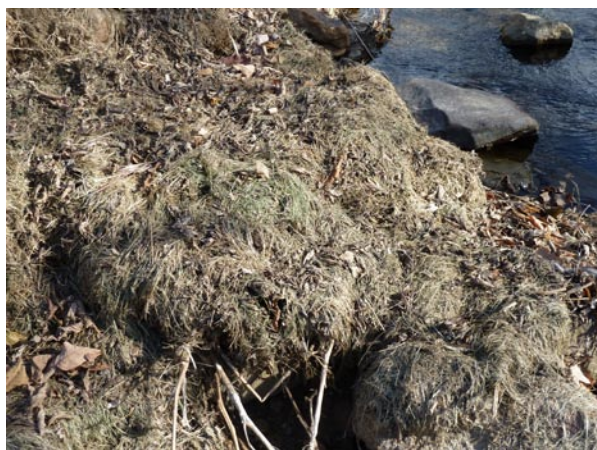
however, that there is a township-wide problem with the dumping of lawn waste along stream banks. Grass clippings disposed of into the stream will decompose, releasing nitrogen into the stream. This can contribute significantly to nutrient enrichment.

Lawn clipping found along the banks of the Trout Creek

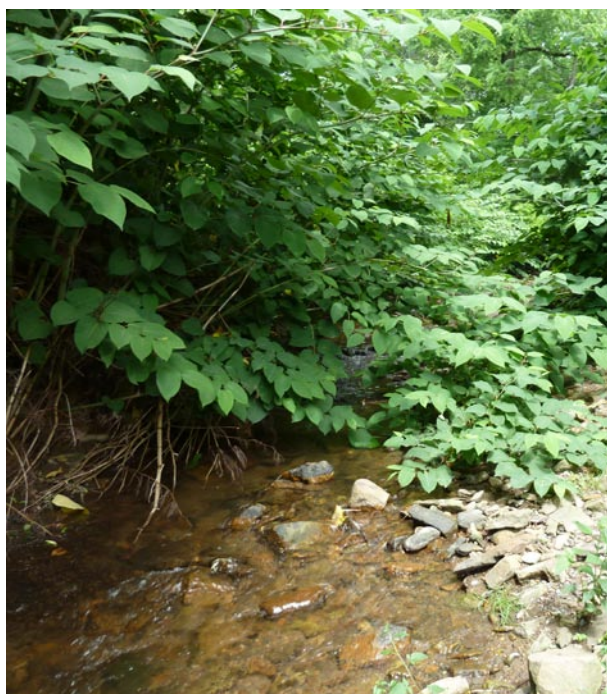
The visual assessment made note of where invasive plants were a significant issue along the Trout Creek. Japanese Knotweed was the most significant invasive plant present.

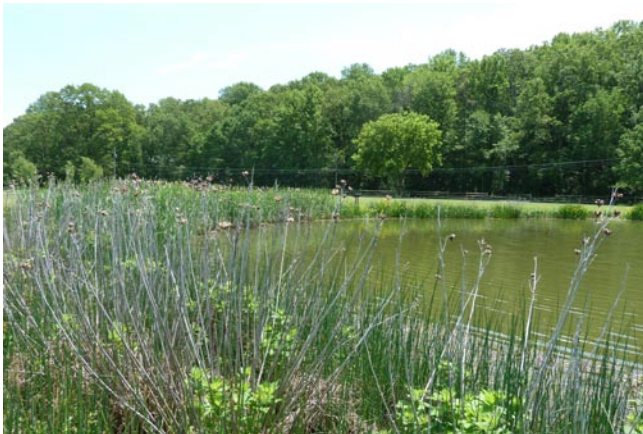
A vegetated buffer around a pond improves water quality and reduces the amount of Canada Geese frequenting the park. This picture was taken in Pranco Park.

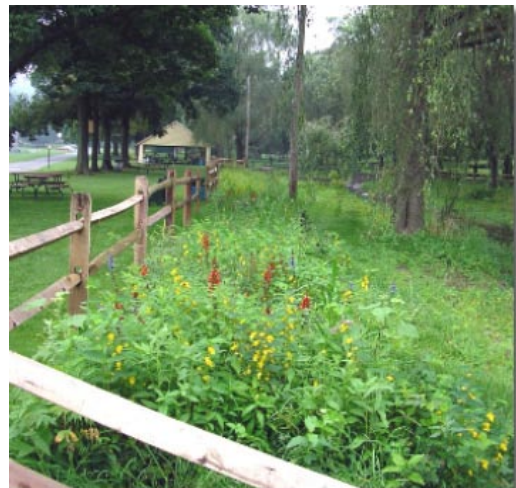
Riparian buffer project at Emmaus Community Park

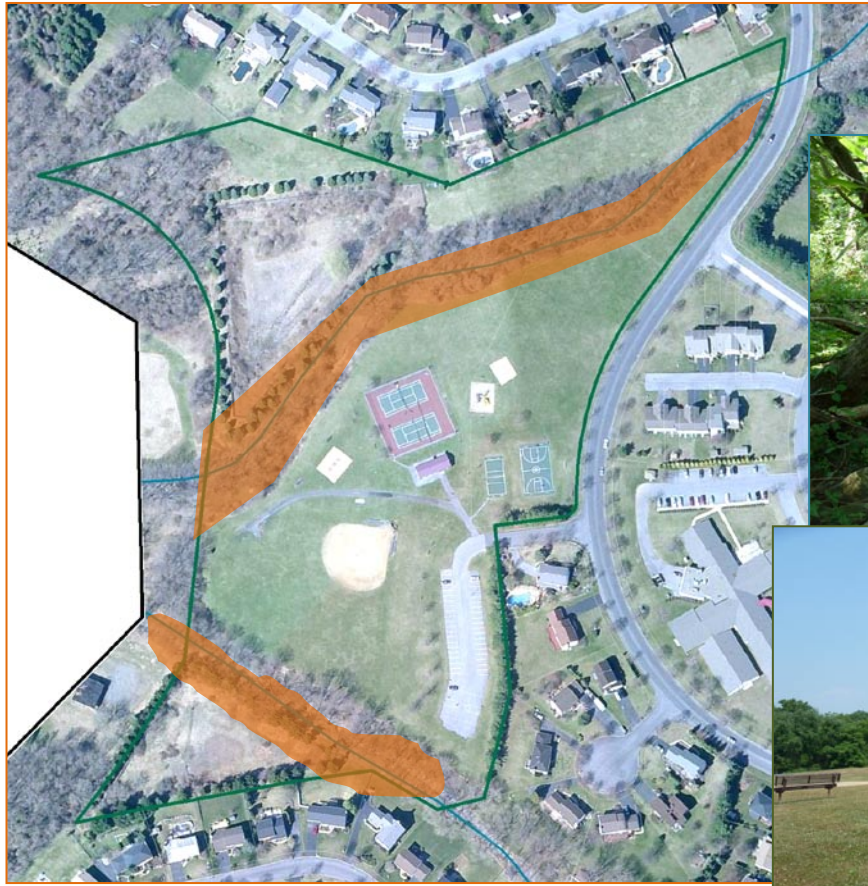
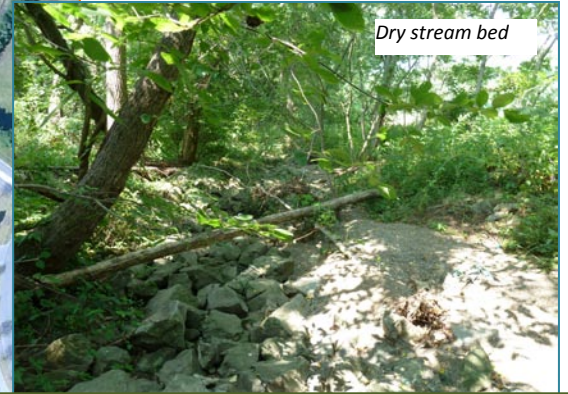
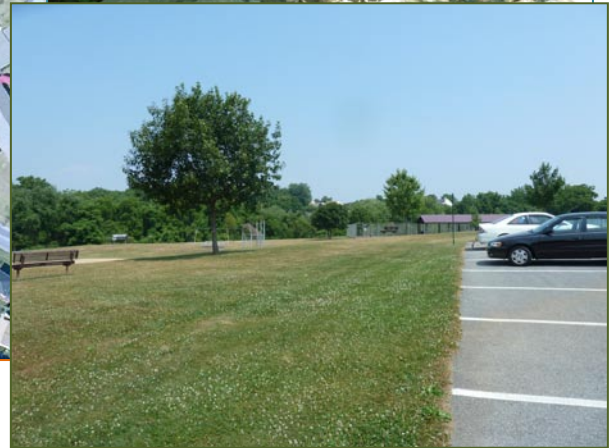
DEVONSHIRE PARK

- The two mapped streams traversing the park have dry beds
- Multiflora rose and oriental bittersweet dominate the vegetation along the stream corridors
- There are several unused areas in lawn grass that could be utilized for native wildflower plantings and educational displays.

- Create community garden site or plant warm season grasses (little bluestem, big bluestem, Indian grass) for bird habitat in the lawn area near the parking lot.
- Girdle stand of Norway maple and replace with tulip poplar.

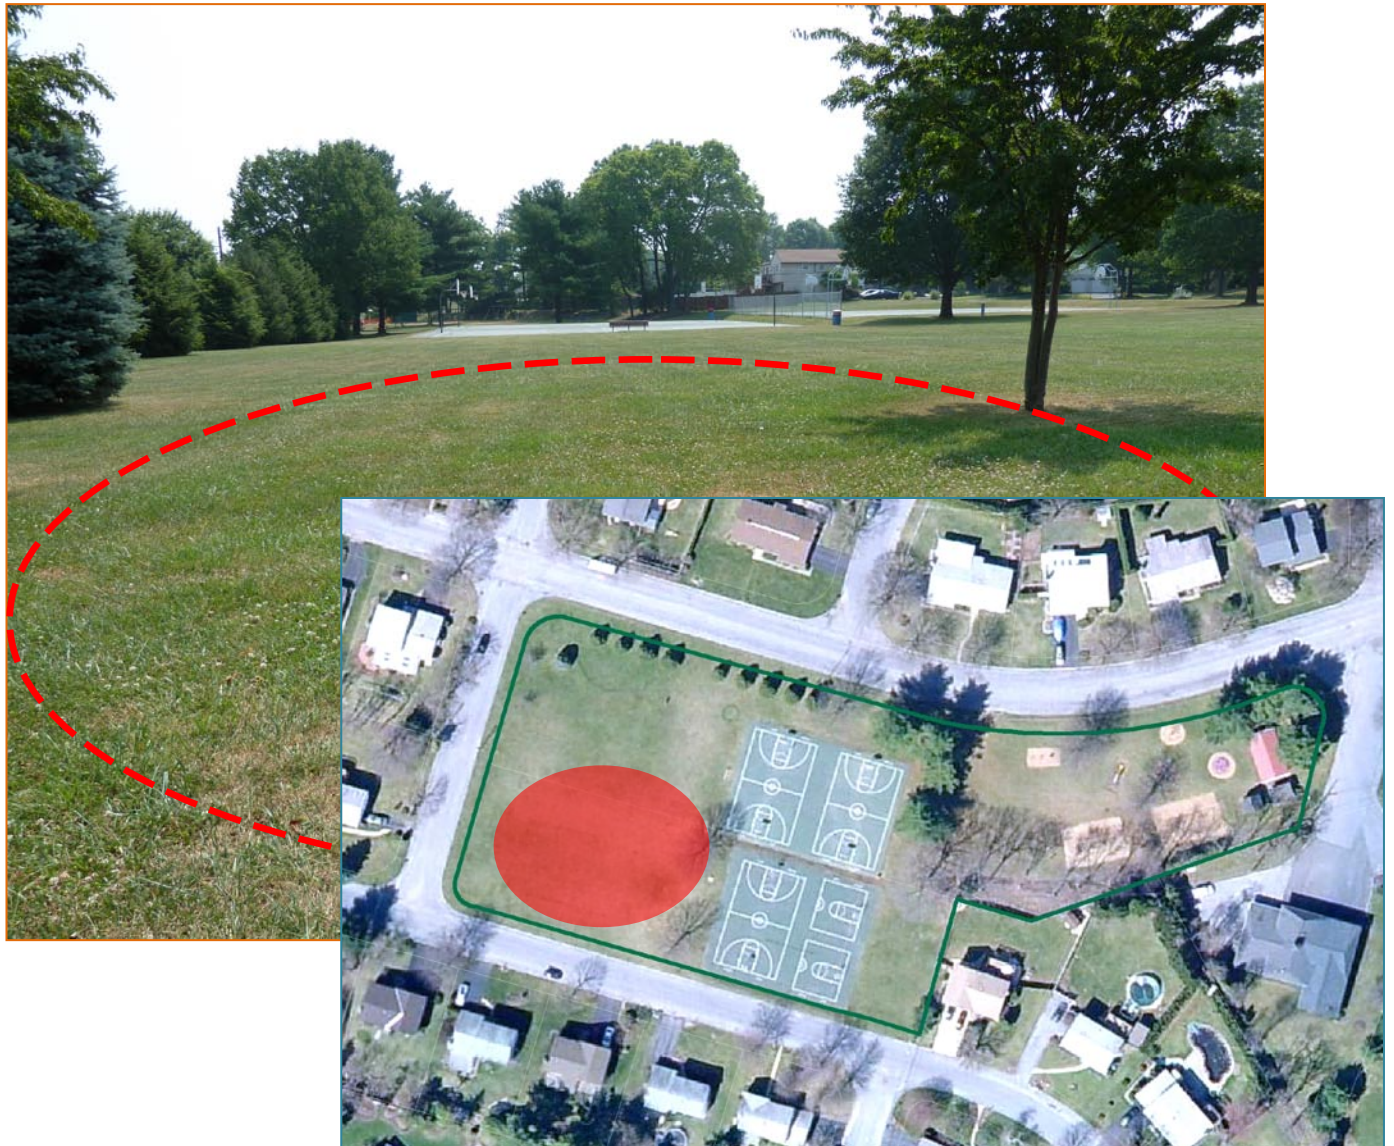
GREEN ACRES PARK

- Large lawn areas in the park have opportunities for naturalized areas and educational signage.

- Turn all or portions of unused lawn area into wildflower meadow with educational signage

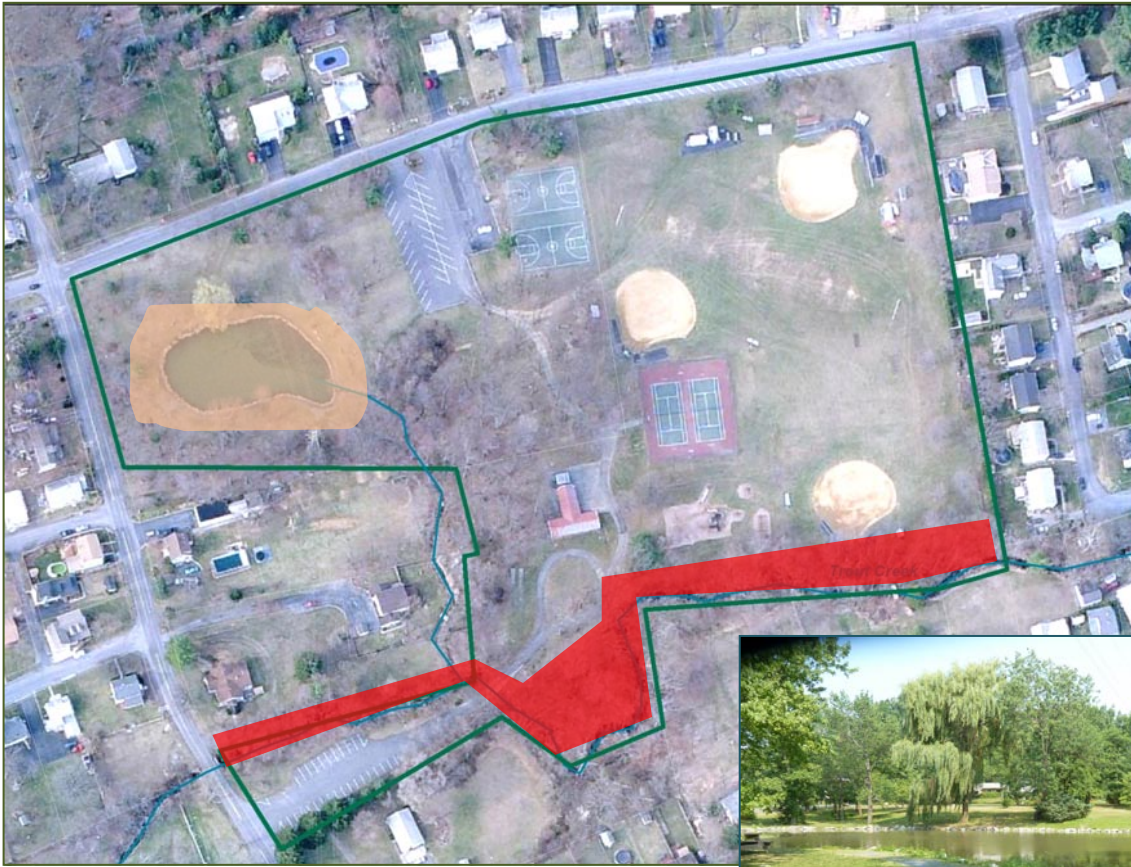
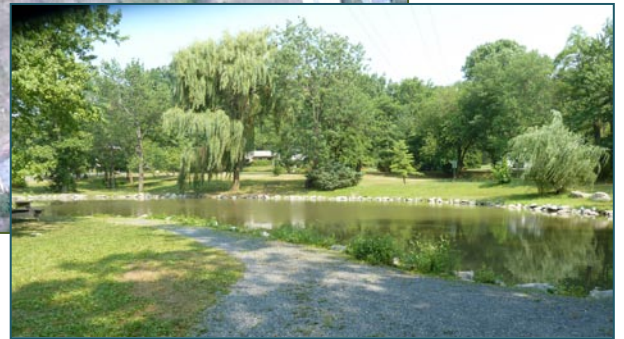
LAUBACH PARK

- Presence of invasive plant species along Trout Creek, predominantly Japanese knotweed and multiflora rose.
- Trout Creek has severe undercuts as it passes through park property, but no structures in jeopardy
- There is an unnamed headwater stream draining off Lehigh Mountain that is fed into a storm drain that crosses Susquehanna Street and feeds the pond in the park.
- The Township currently mows to the edge of the pond and there is a substantial population of Canadian Geese.
- Park contains a fair diversity of trees.

- Remove invasive plants along Trout Creek banks and replace with native species.
- Reduce mowing around the edges of the pond and create access paths that zigzag through native vegetation to decrease the number of Canadian geese and improve water quality.

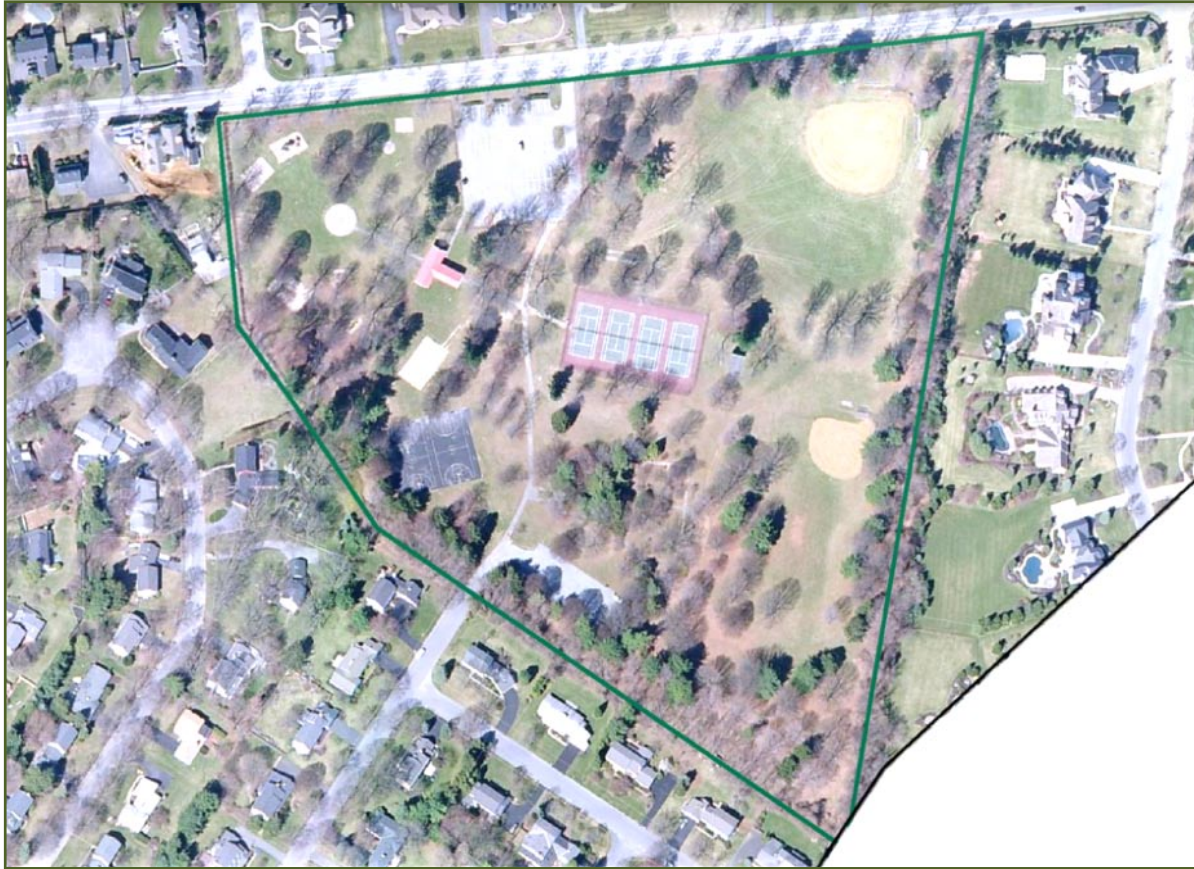
LINDBERG PARK

- There is a diversity of tree species along walking paths and unused lawn areas.

- Consider Tree Identification signs throughout the park.
- Create small, wildflower meadows in out-of-play areas.

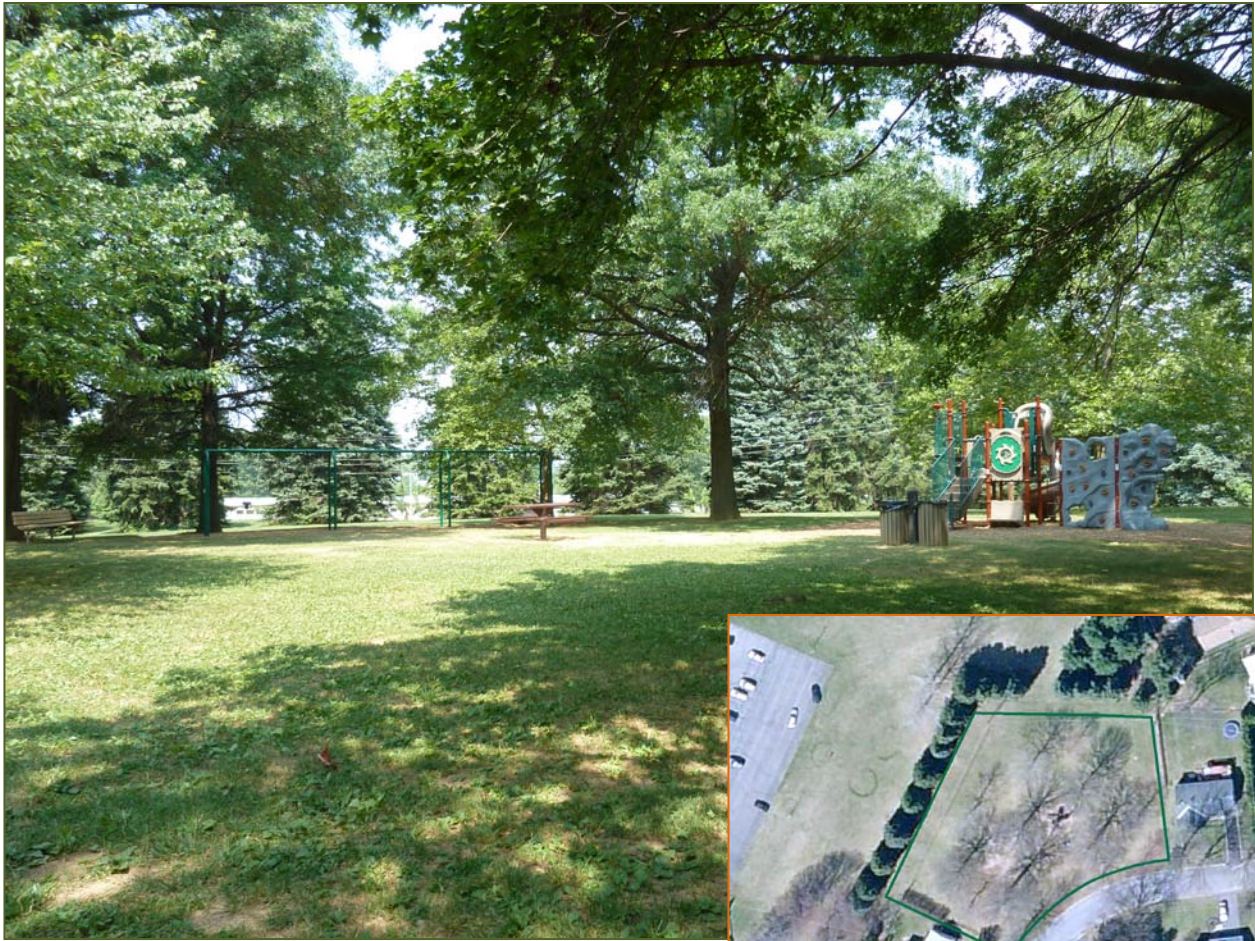
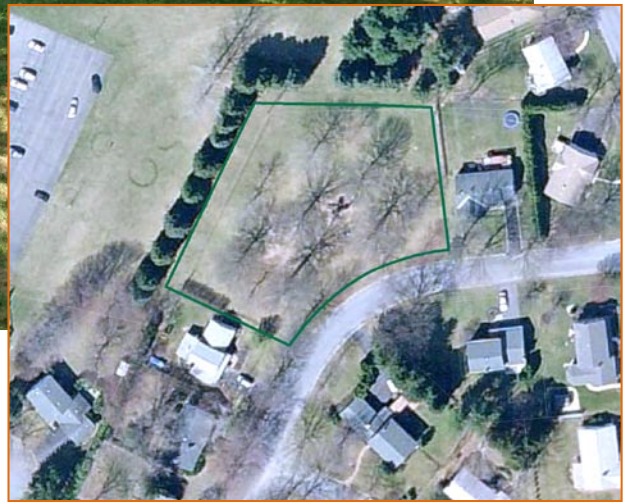
LOUISE LANE PARK

- Park only contains play lot and benches, but there is room to enhance the park with native plantings and educational displays

- Create butterfly garden with educational signage in unused lawn areas
- Ensure replacement landscaping trees are native

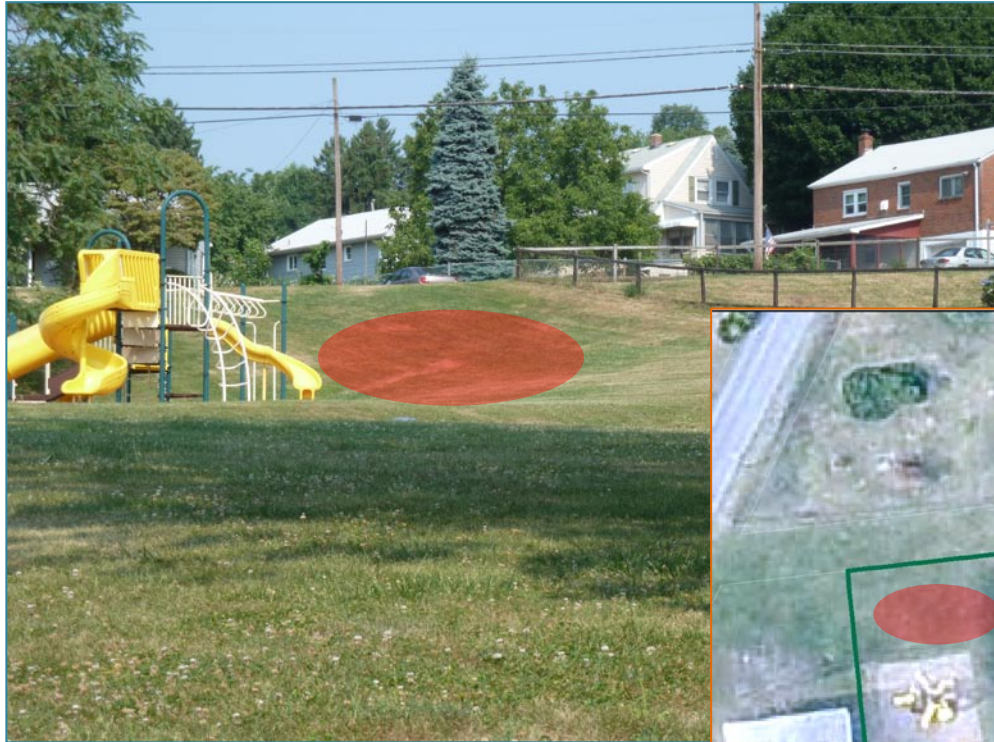
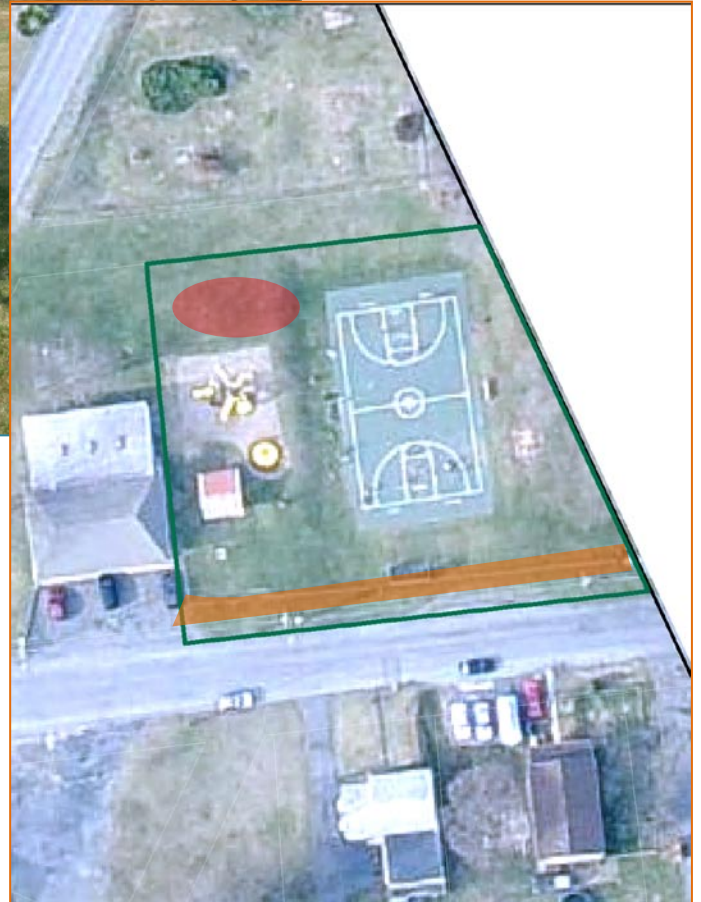
RIVER ROAD PLAY LOT

- Considerable flow coming out of pipe near edge of park

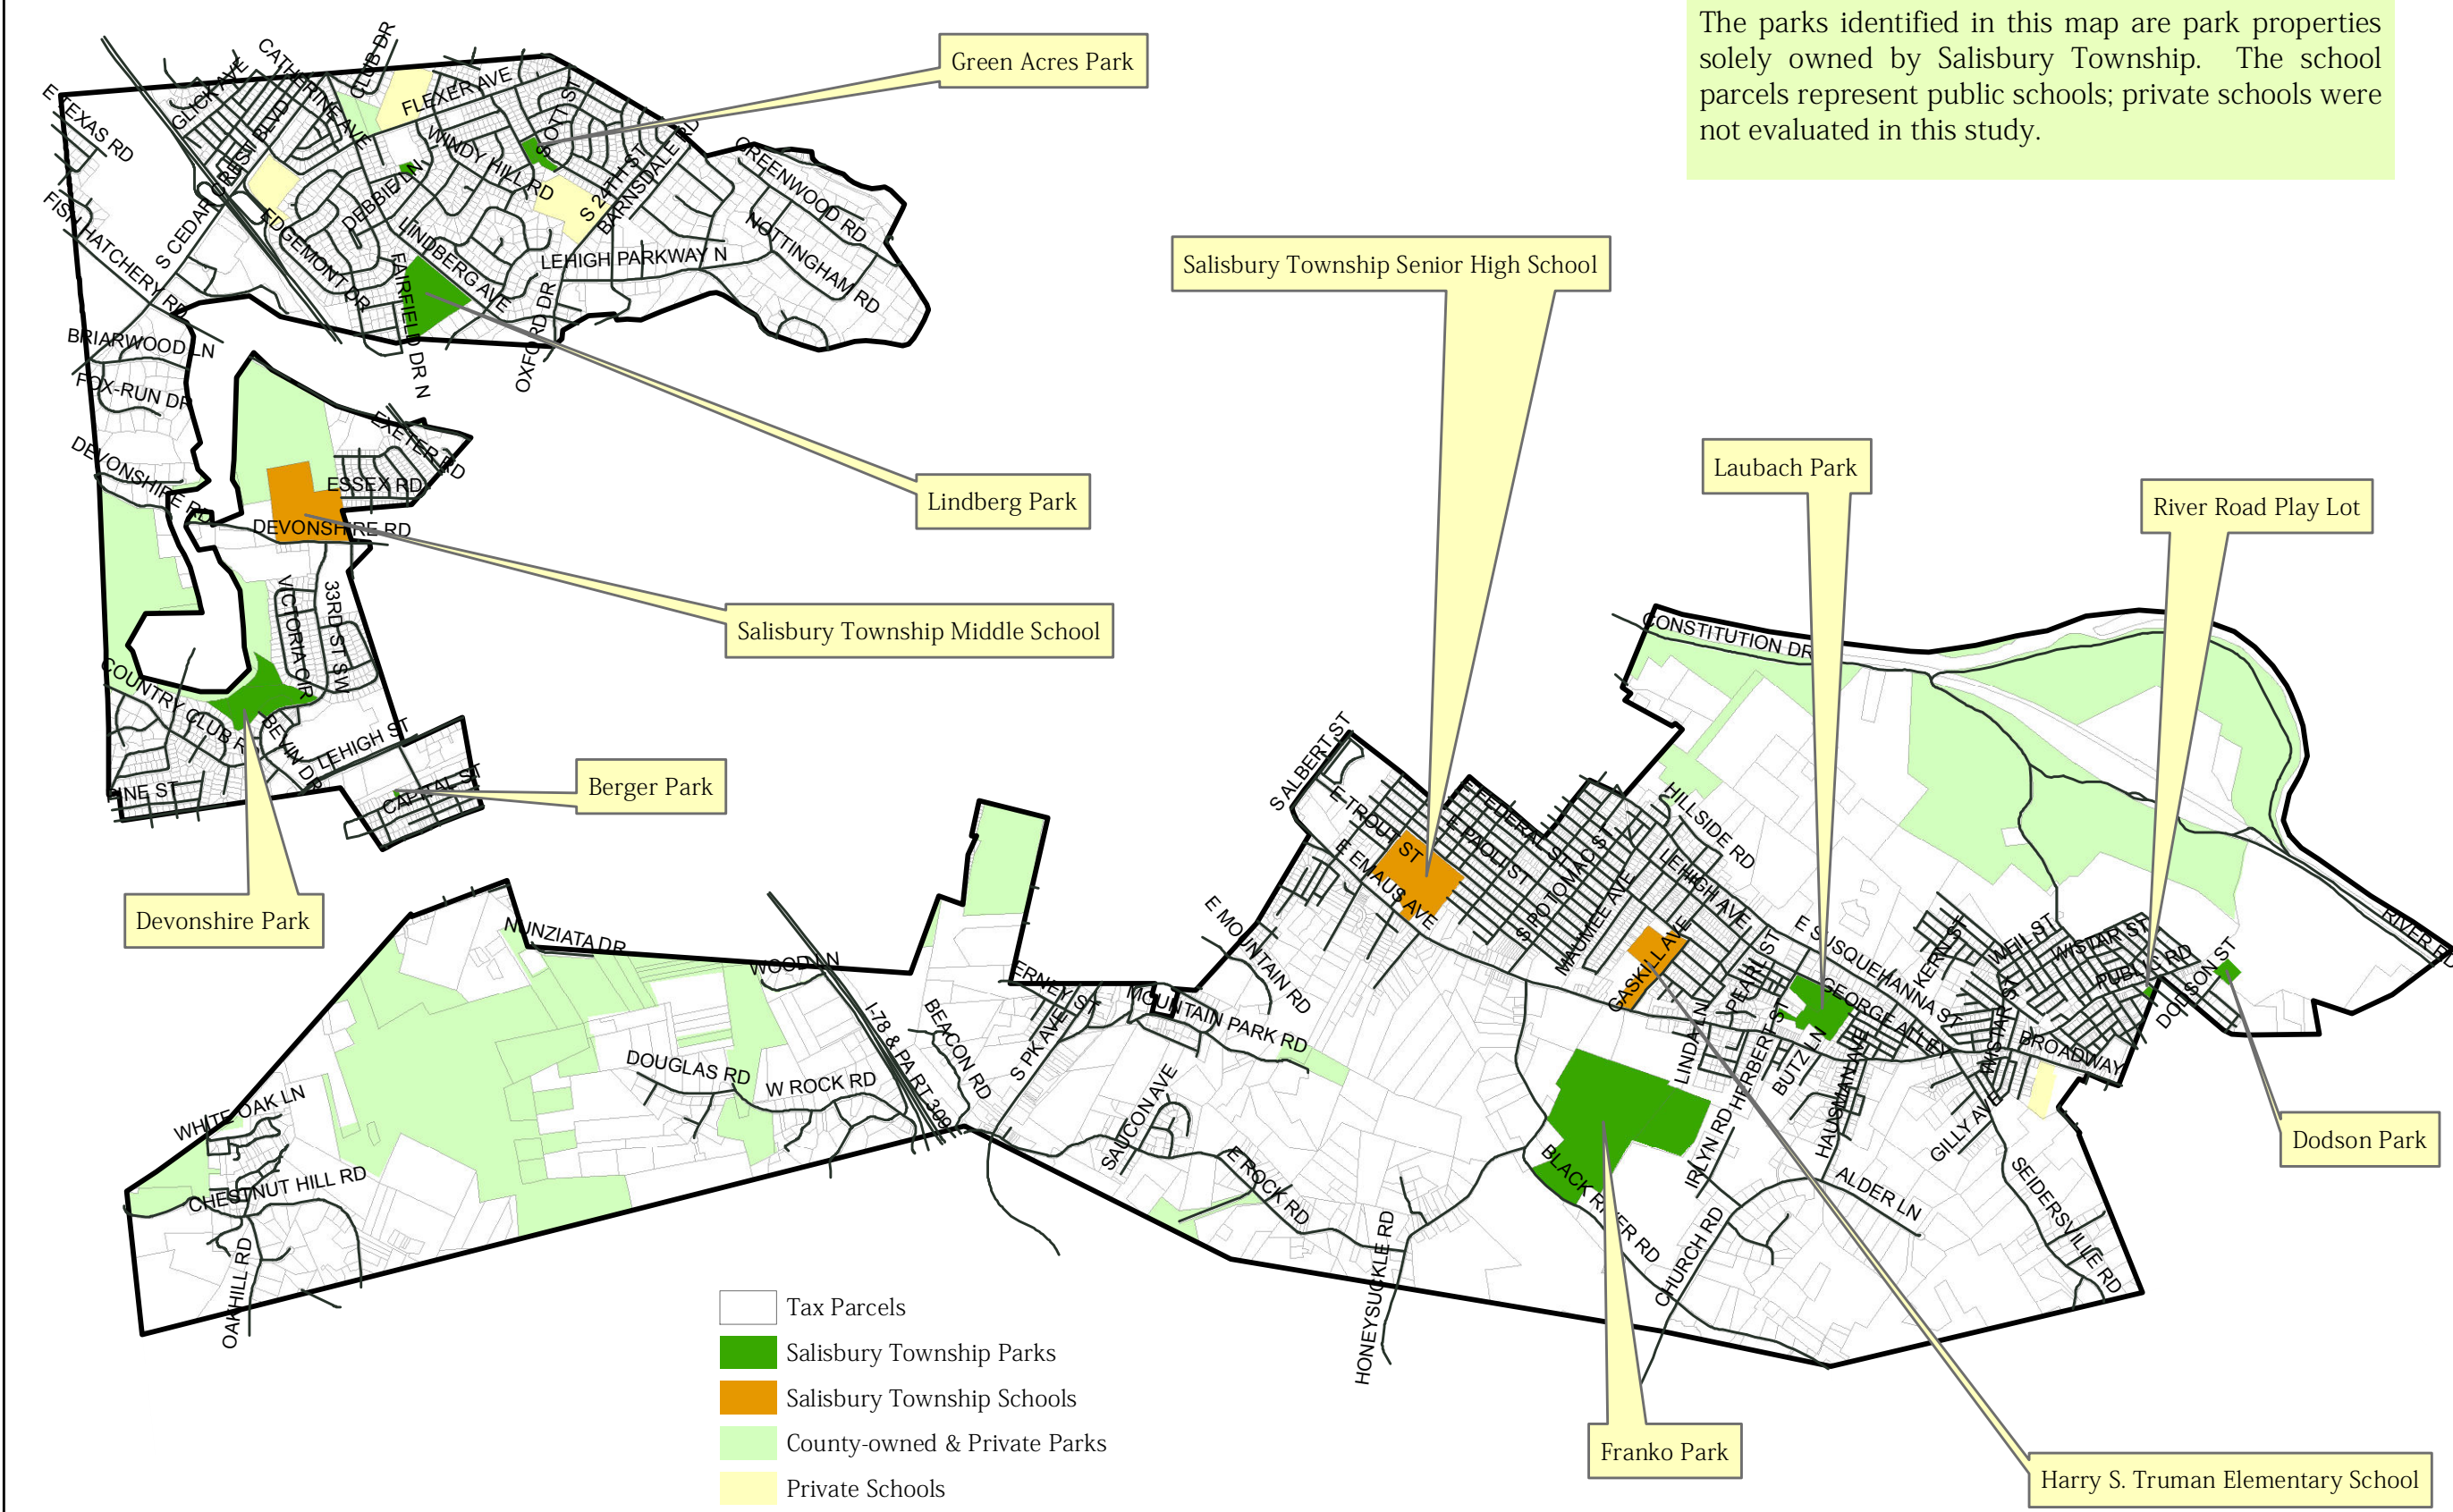
This map contains the designated uses and impairment status of the mapped streams in Salisbury Township. Any unmapped tributaries upslope from a mapped stream will share the receiving stream's designated use and impairment.

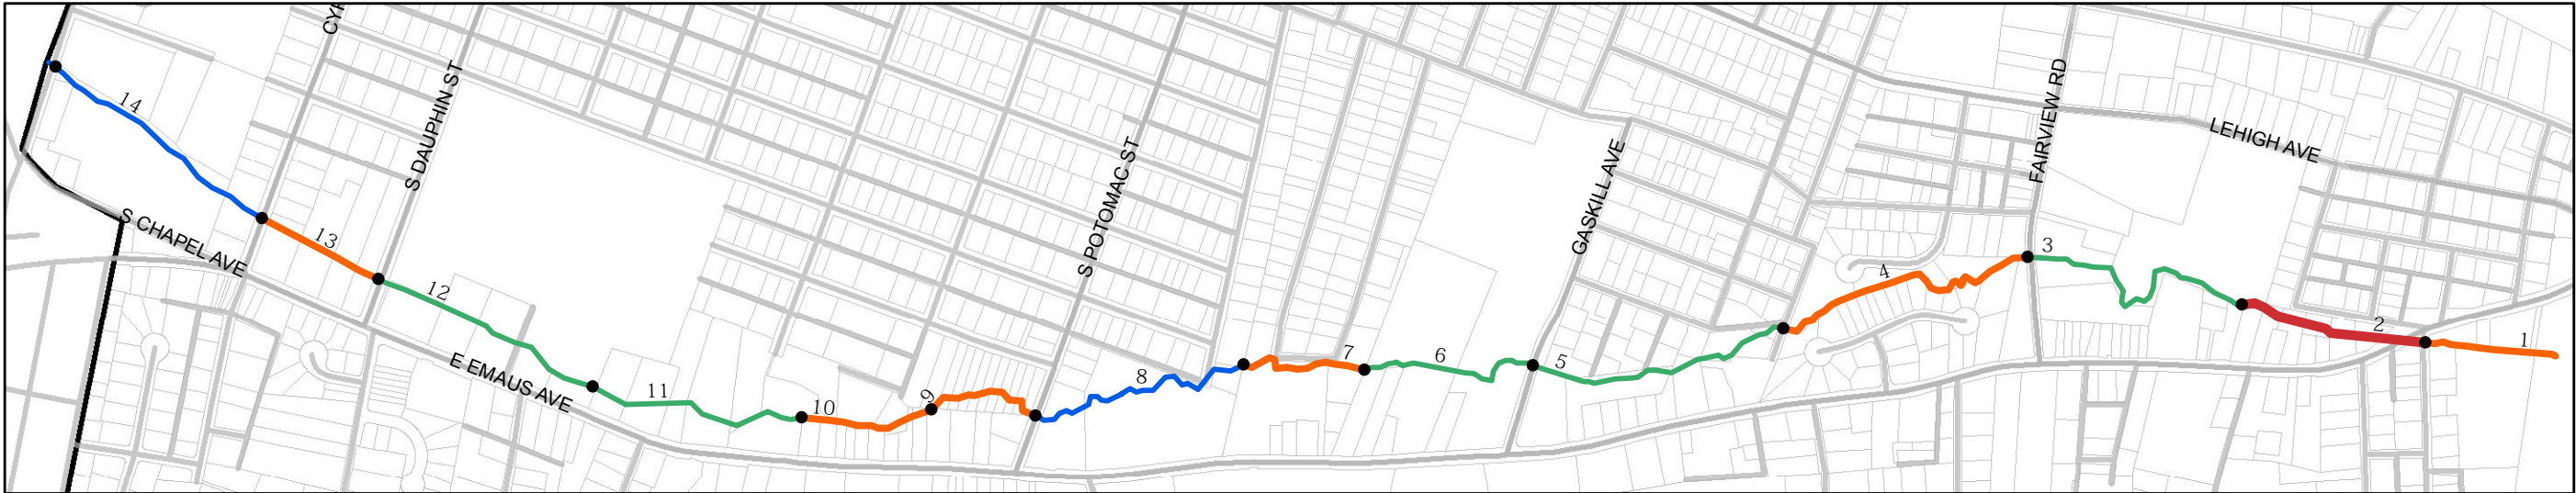
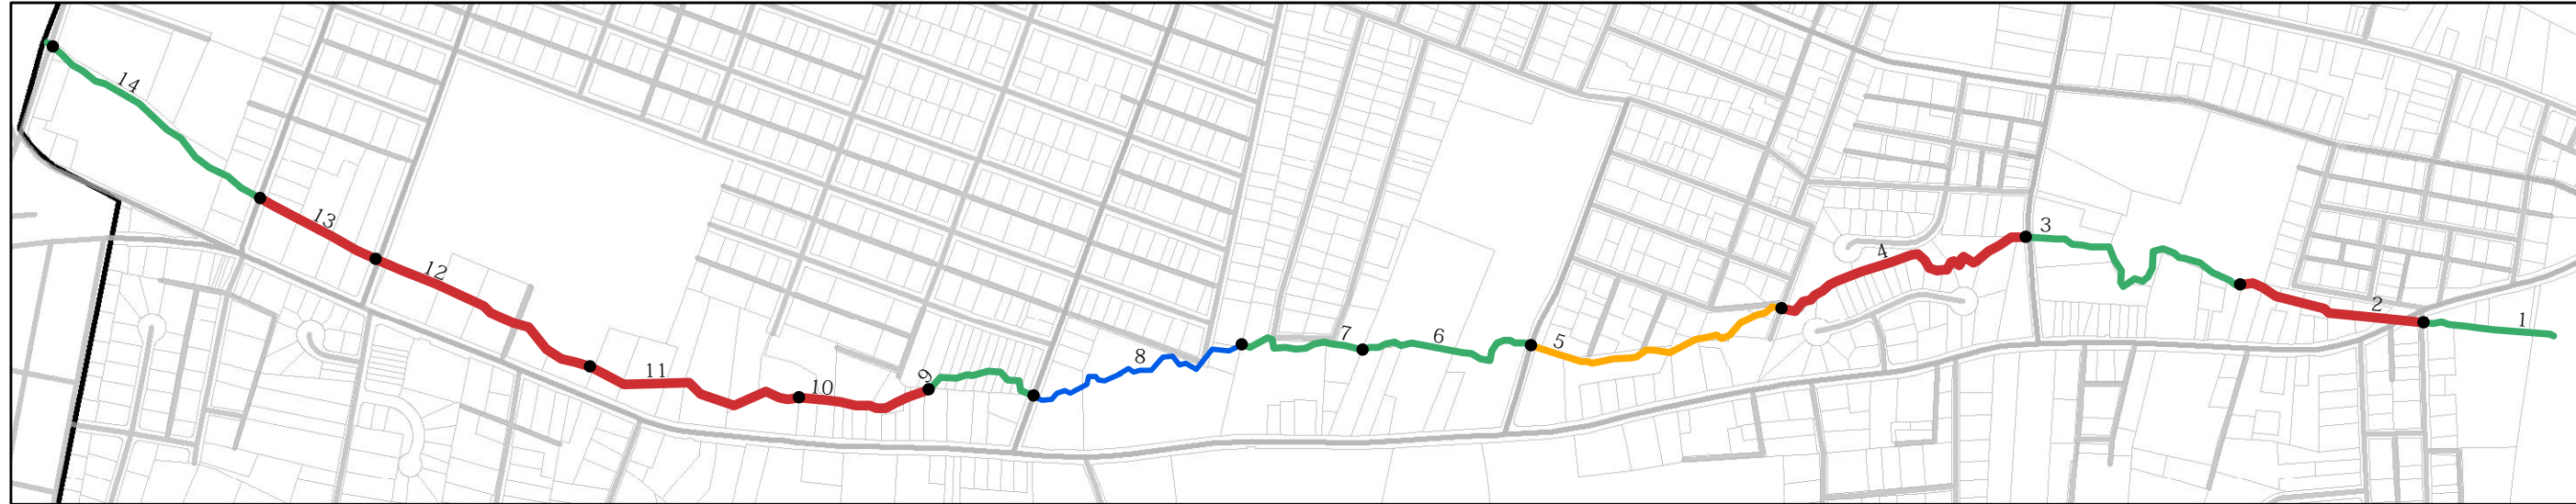
SALISBURY TOWNSHIP
Trout Creek Visual Assessment

The numbers along each stream segment correspond to the reach identification numbers in the visual assessment data sheets.
